Test items and Conclusion

Test Report

Results of Stress-strain & Tensile performance test

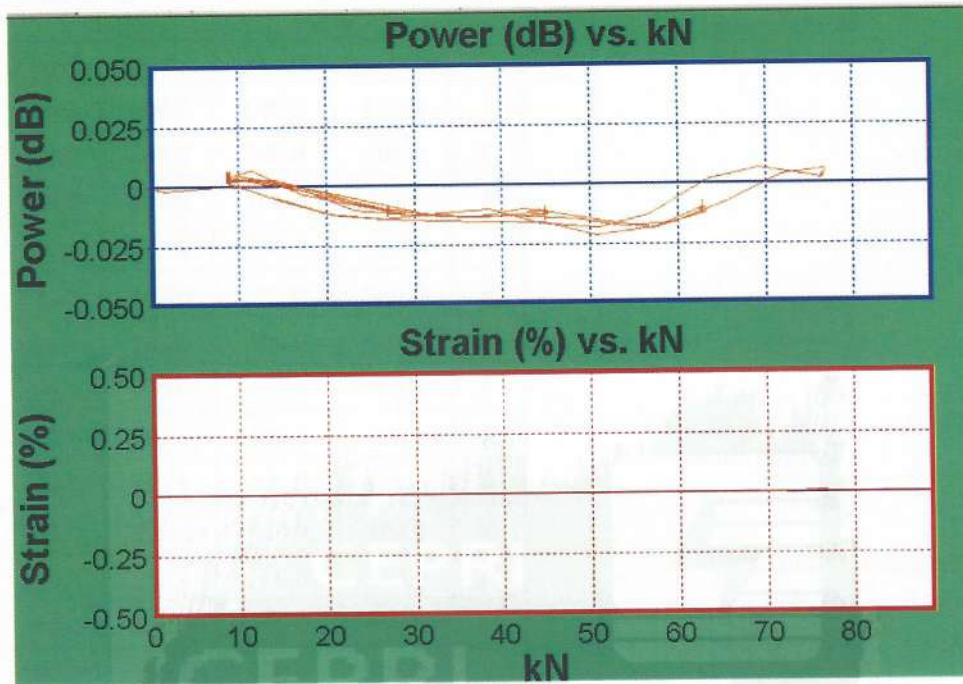
Figure 1-1: Optical Attenuation and Fiber Strain curve

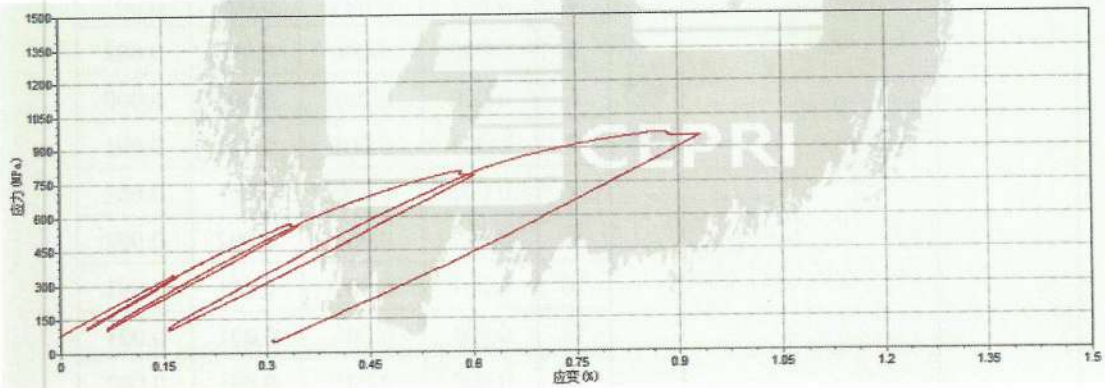
Figure 1-2: Stress-strain

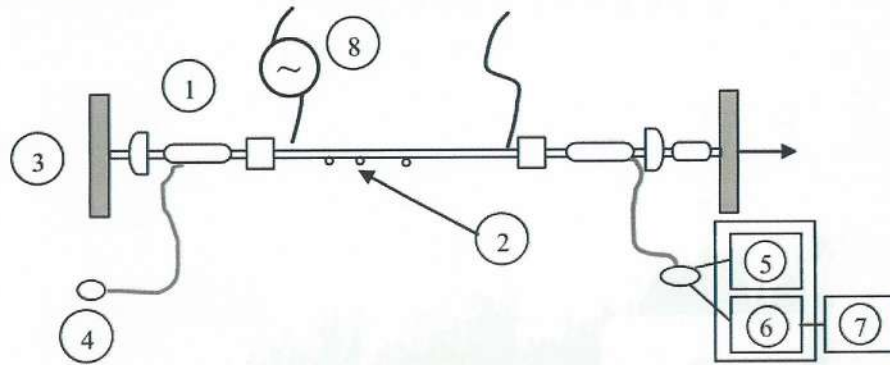
1. OPGW sample 2. thermocouple 3. Anchoring clamps 4. Fiber loop 5. light Source 6. Optical power meter
7. Data record meter 8. External power source line

Figure 2-1 Short-circuit current test setup

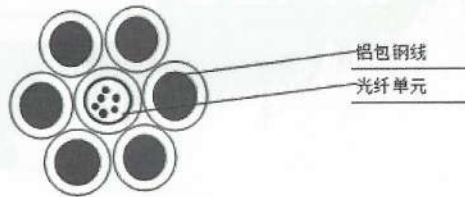
Figure 2-2 Figure for the thermocouple position

Thermocouple #1 – The OPGW cable surface

Thermocouple #2 –optical tube

Thermocouple #3 –Between AS wires and Optical tube

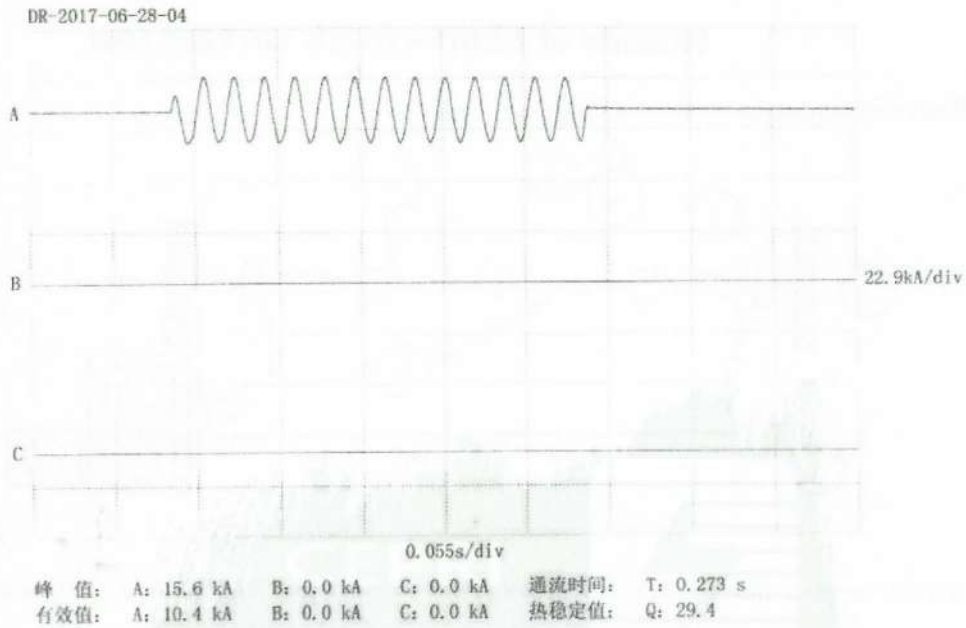
Figure 2-3 Waveform of pulse

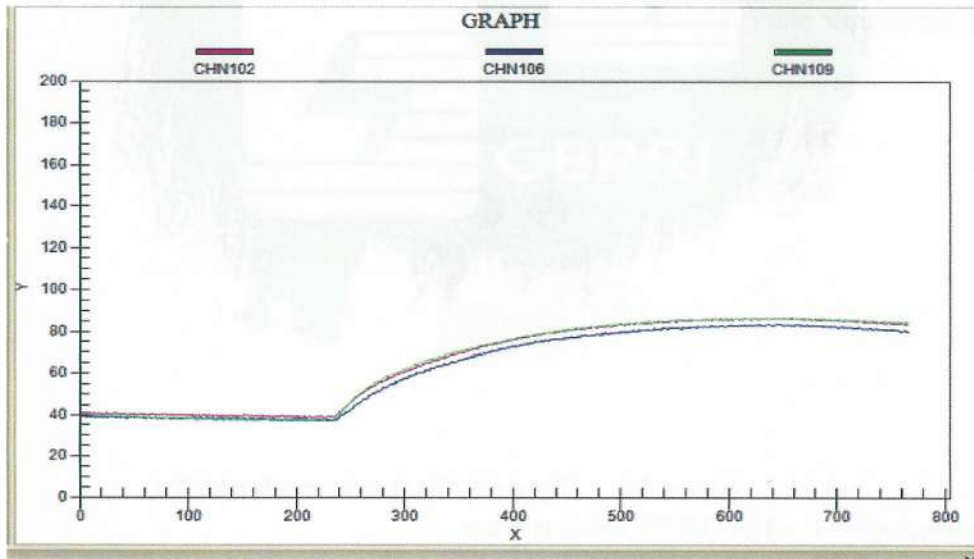
The OPGW cable surface

80.4 °C (Blue)

optical tube

84.6°C (Green)

Between AS wires and Optical tube

83.7°C (Purple)

Figure 2-4 Temperature rise curve

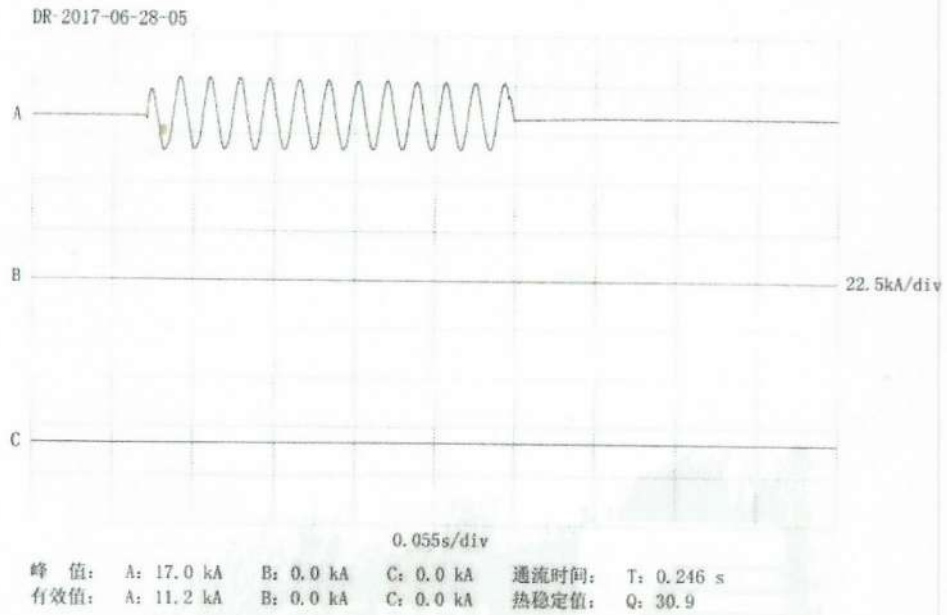
Figure 2-5 Waveform of pulse

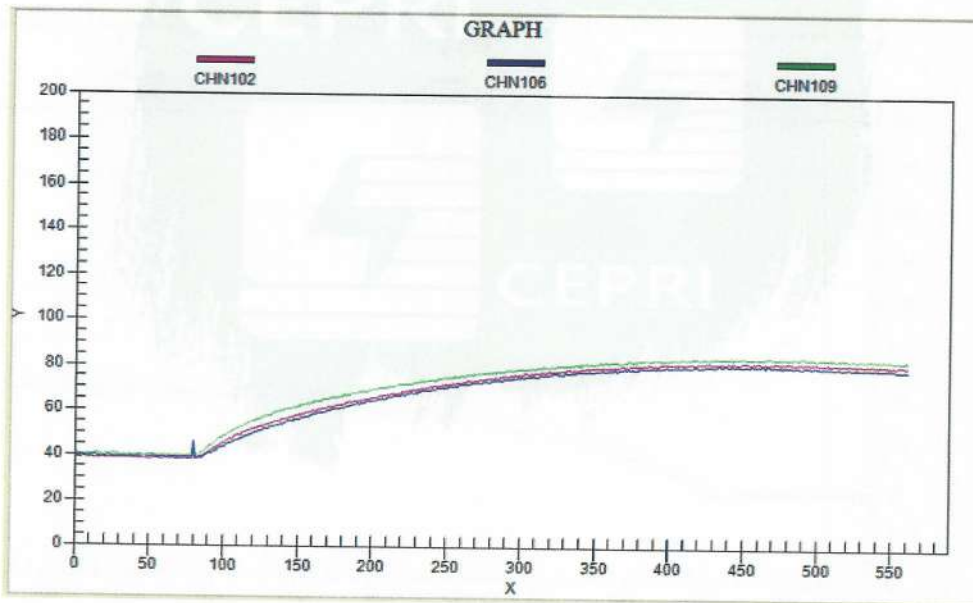
The OPGW cable surface	79.1 °C (Blue)
optical tube	83.3 °C (Green)
Between AS wires and Optical tube	80.7 °C (Purple)

Figure 2-6 Temperature rise curve

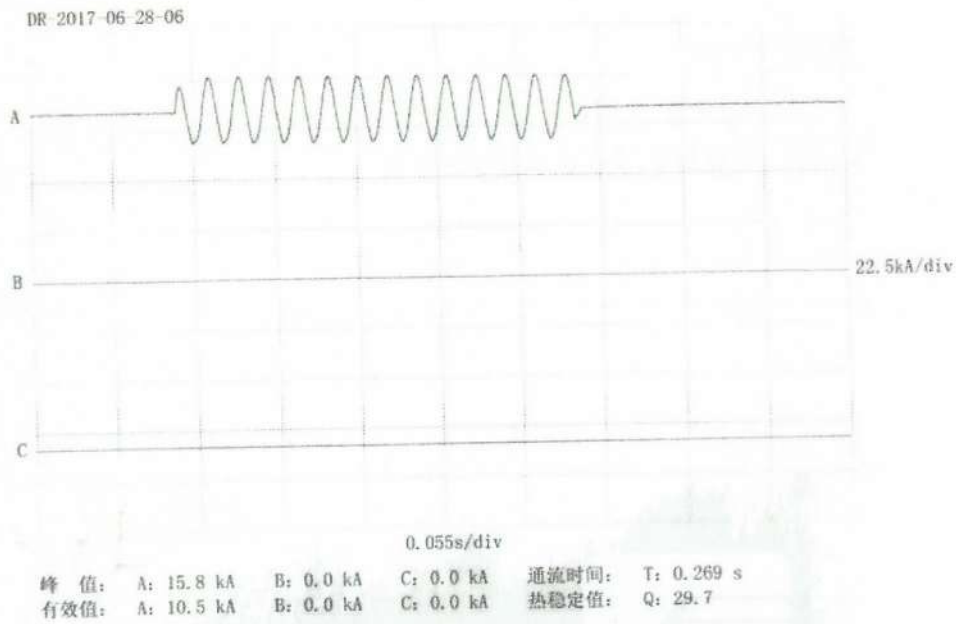
Figure 2-7 Waveform of pulse

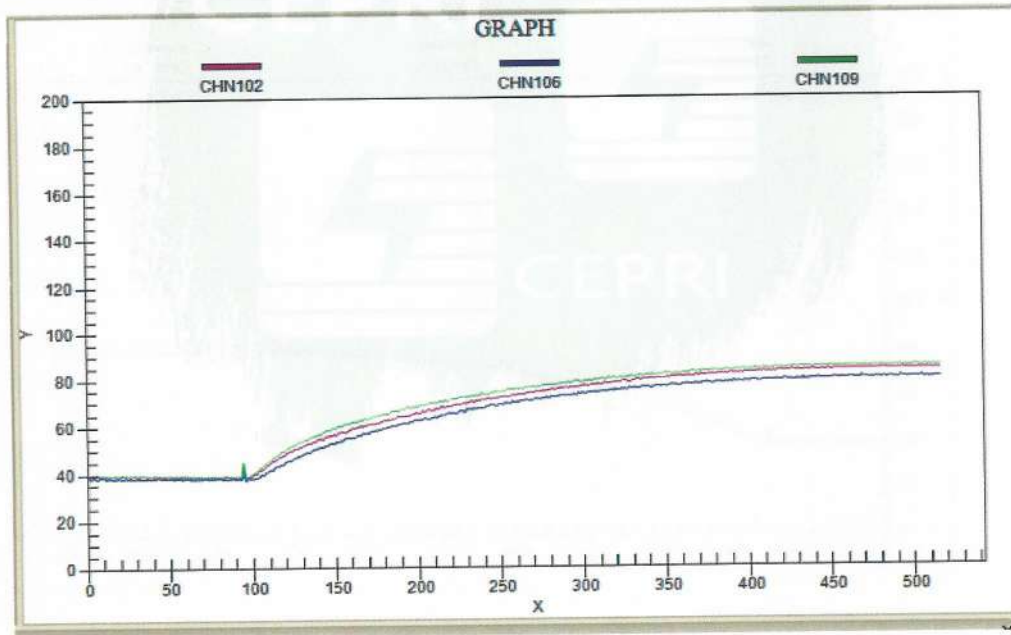
The OPGW cable surface
optical tube

79.8°C (Blue)

84.8°C (Green)

Between AS wires and Optical tube

83.5°C (Purple)

Figure 2-8 Temperature rise curve

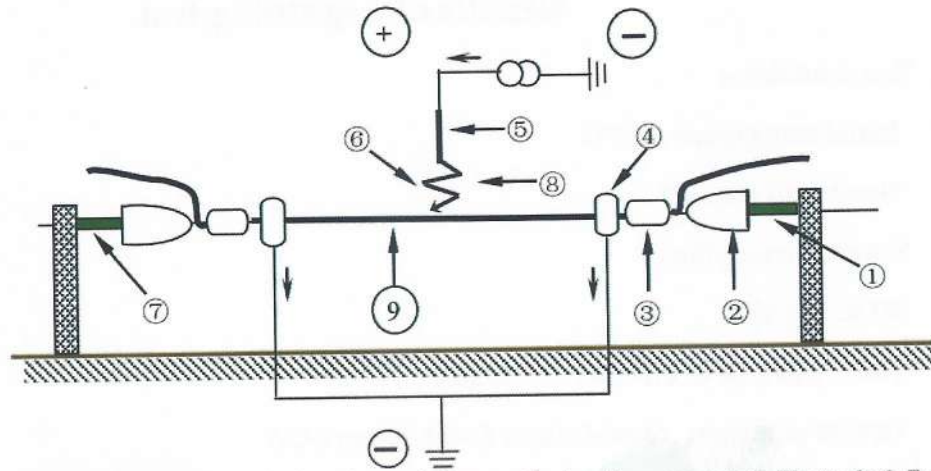
1. Turnbuckle 2. Insulator 3. Anchoring clamps 4. Symmetrical earth connectors 5. Electrode 6. Fuse 7. Tension meter 8. Gap between electrode and cable surface 9. OPGW test sample

Figure3-1 Lightning test setup

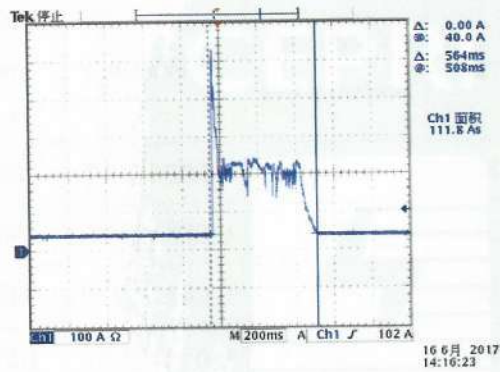
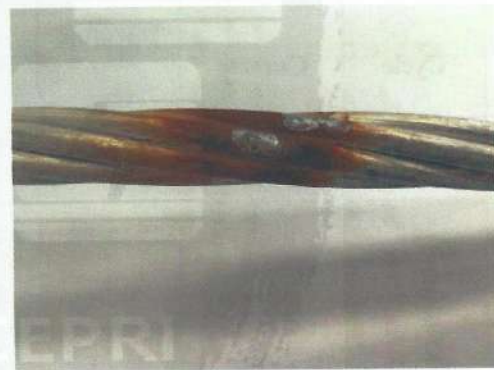
Figure 3-2 1st lightning result

Cycle	Current	Duration time	Charge	Number of broken wires	Attenuation	Calculated residue tension
1st	200A	564ms	111.8C	0	0.003 dB/纤	100%RTS
2nd	200A	576ms	117.2C	0	0.005 dB/纤	100%RTS
3rd	200A	568ms	108.9C	0	0.003 dB/纤	100%RTS
4th	200A	548ms	103.8C	0	0.004 dB/纤	100%RTS
5th	200A	544ms	103.0C	0	0.005dB/纤	100%RTS

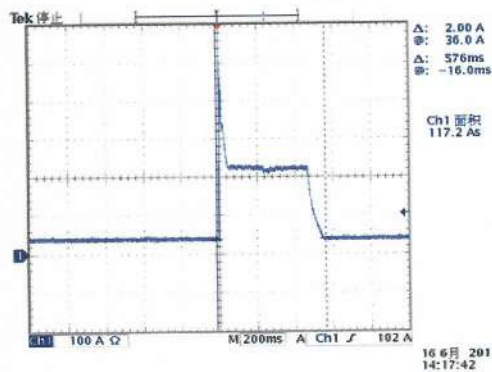
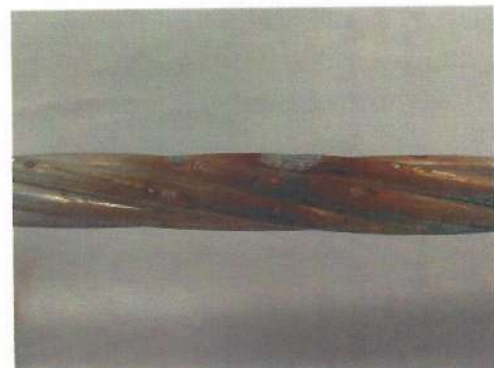
Figure 3-3 2nd lightning result

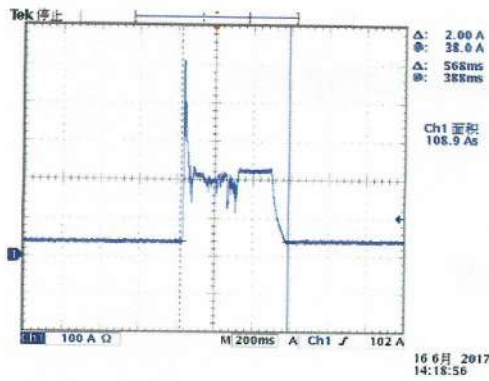
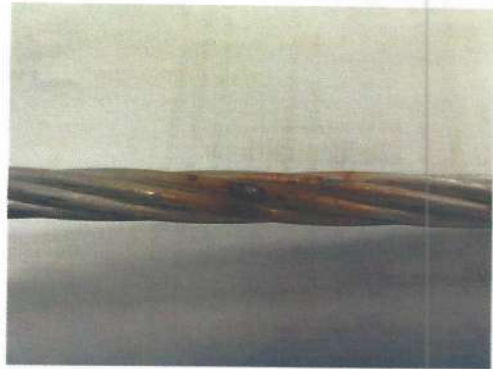
Figure 3-4 3rd lighting result

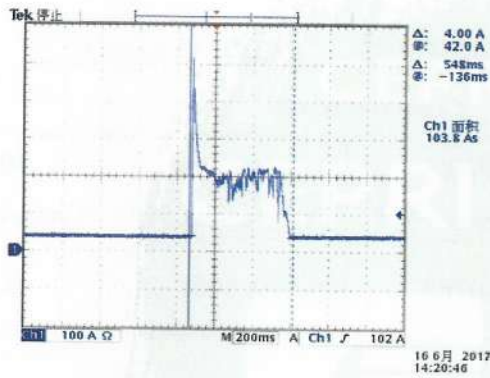
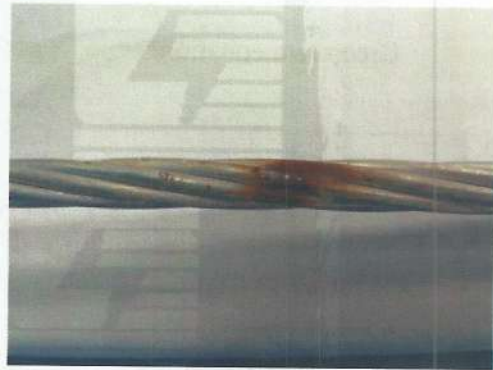
Figure 3-5 4th lighting result

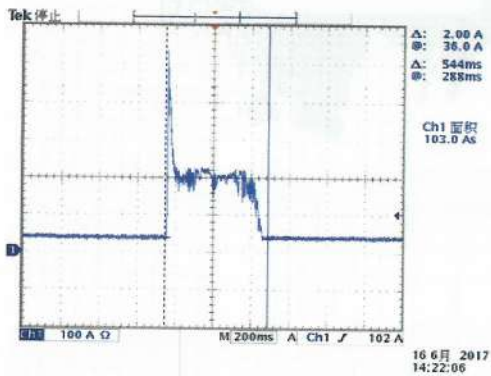
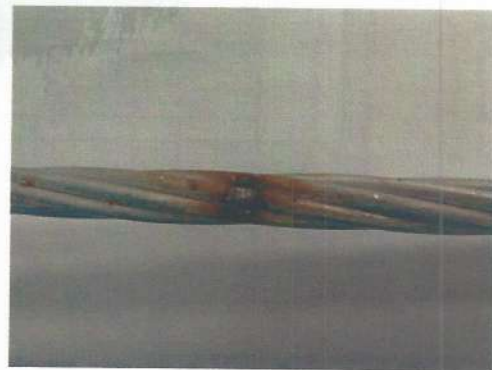
Figure 3-6 5th lighting result

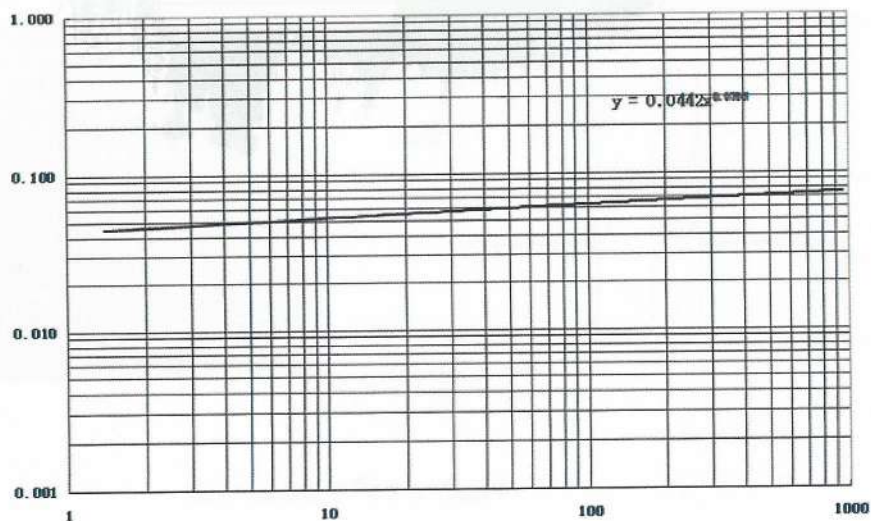
Creep rate equation: $\epsilon = 0.0422T^{0.0765}$ (Where T: hours)

Figure 4-1 Fitting curve of creep test

Tension	Creep rate equation (%)	1000h Creep rate (%)	10 years Creep rate (%)	30 years Creep rate (%)
25%RTS	$0.0422T^{0.0765}$	0.0750	0.1056	0.1148
